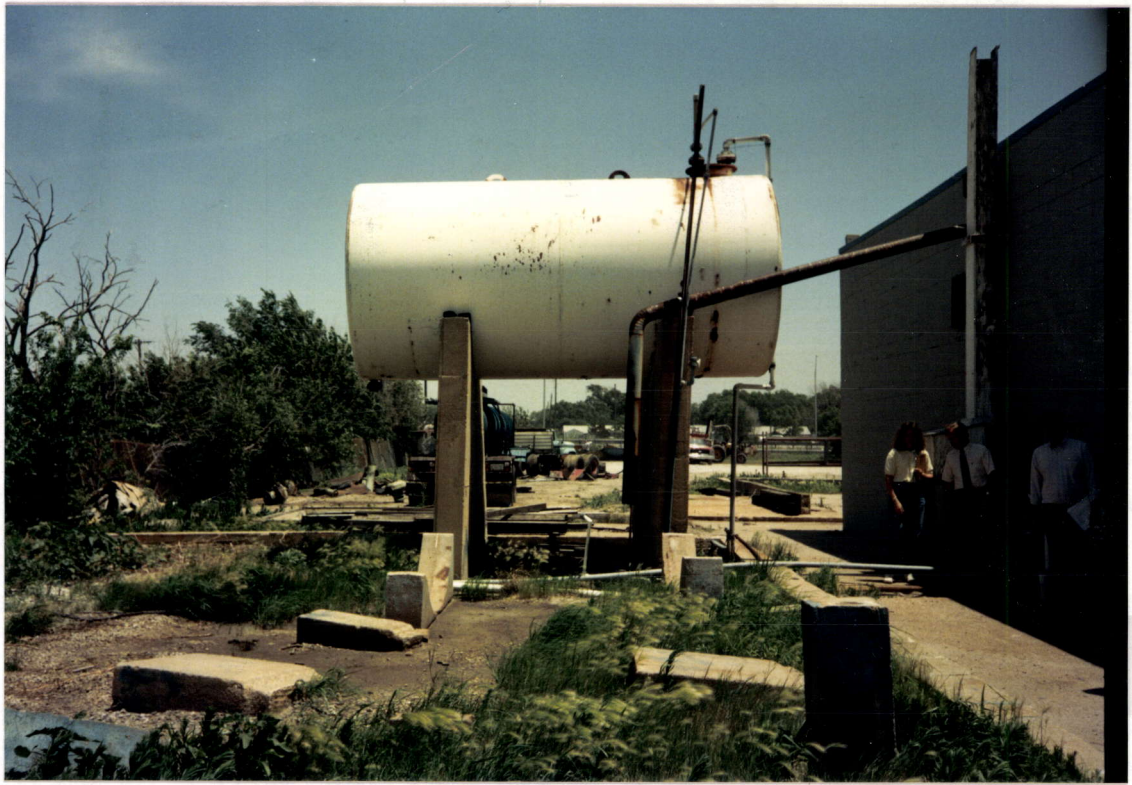
Film Roll No.: 2 Date: 6/19/90 Time: 1420
 Exposure No.: 18 Photographer: JPN
 VSI Observations: Out-of-service muriatic acid storage tank; previously
pipied into acid repackaging area inside Bldg. 17. Tank now empty. View - E

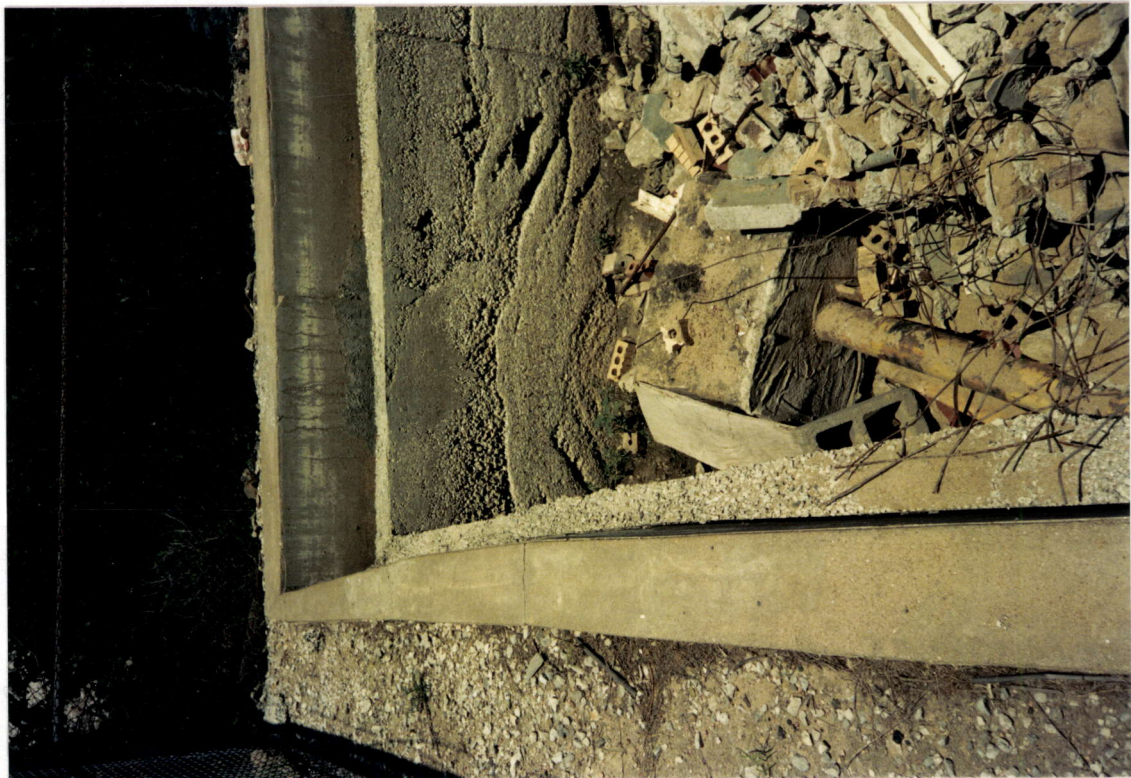
Film Roll No.: 2 Date: 6/19/90 Time: 1422
 Exposure No.: 19 Photographer: JPN
 VSI Observations: Debris-filled former still cooling water sump (Note
etching of concrete & bowing of side wall). View - N

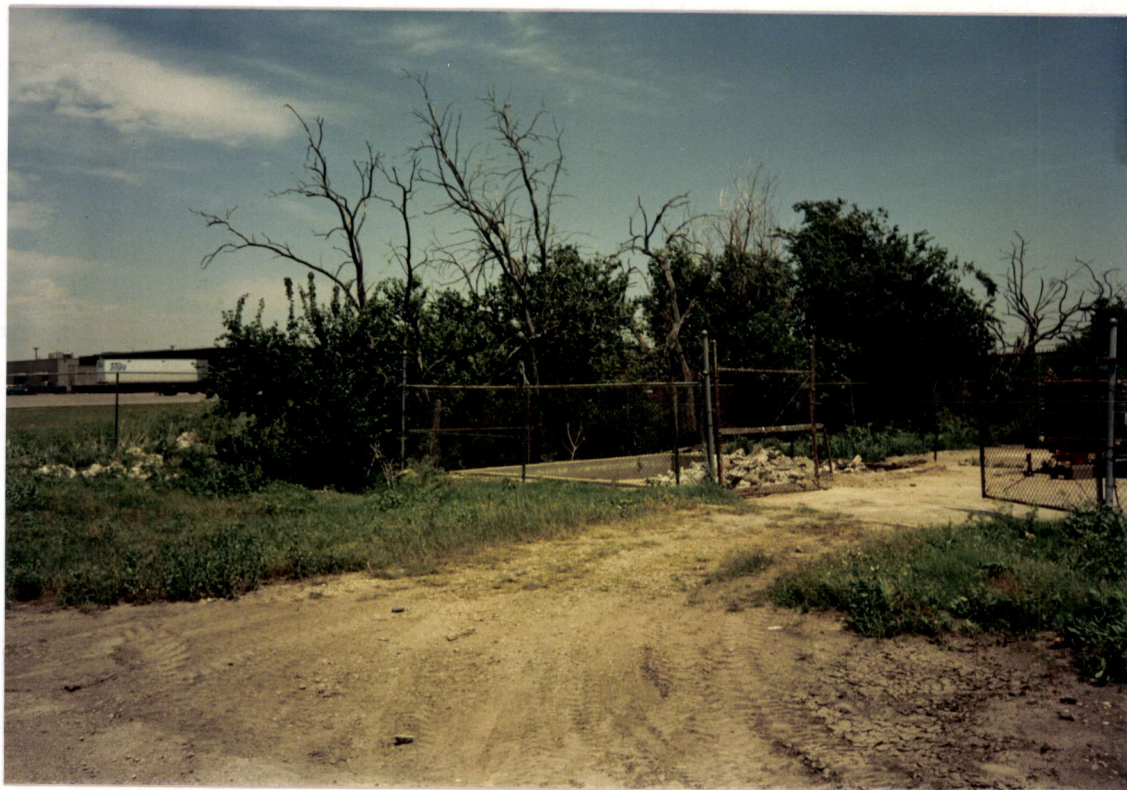
Film Roll No.: 2 Date: 6/19/90 Time: 1425
Exposure No.: 20 Photographer: JPN
VSI Observations: NW corner of SCSC property (debris-filled concrete tank
area). View - NE

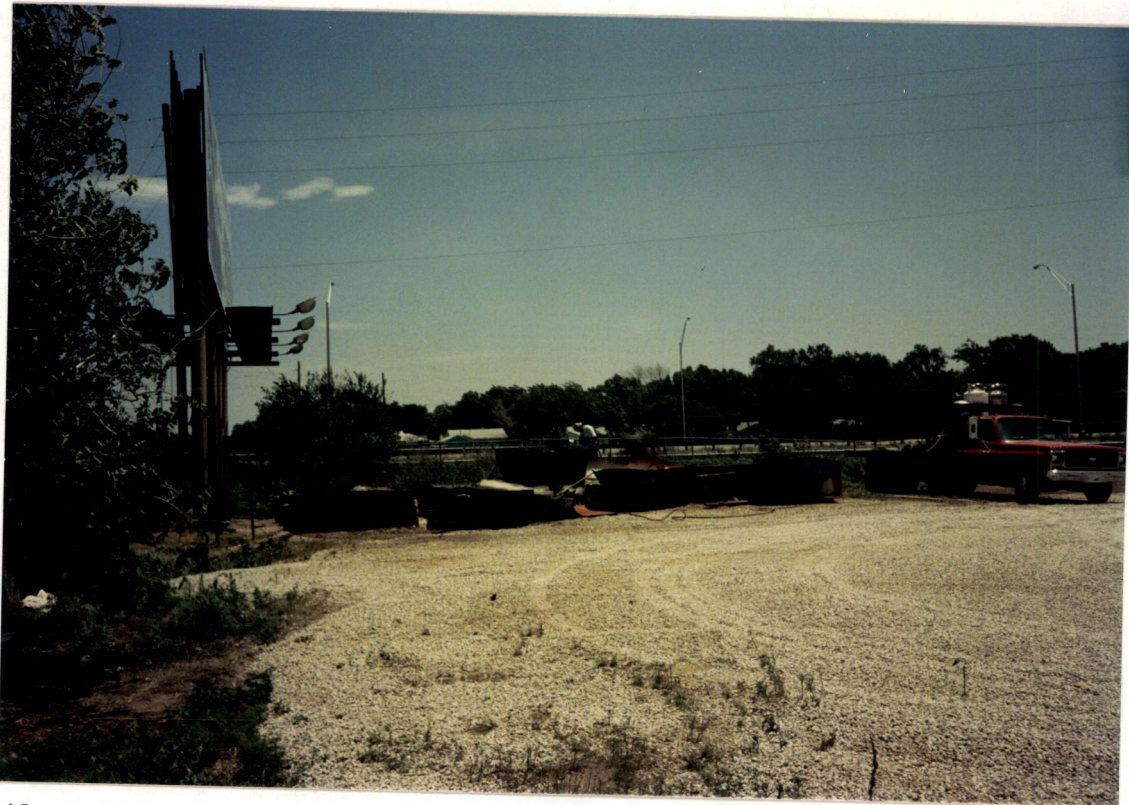
Film Roll No.: 2 Date: 6/19/90 Time: 1410
 Exposure No.: 14 Photographer: JPN
 VSI Observations: Disassembly of 4 former storage tanks performed by SCSC
personnel at northeast corner of SCSC property. View - E

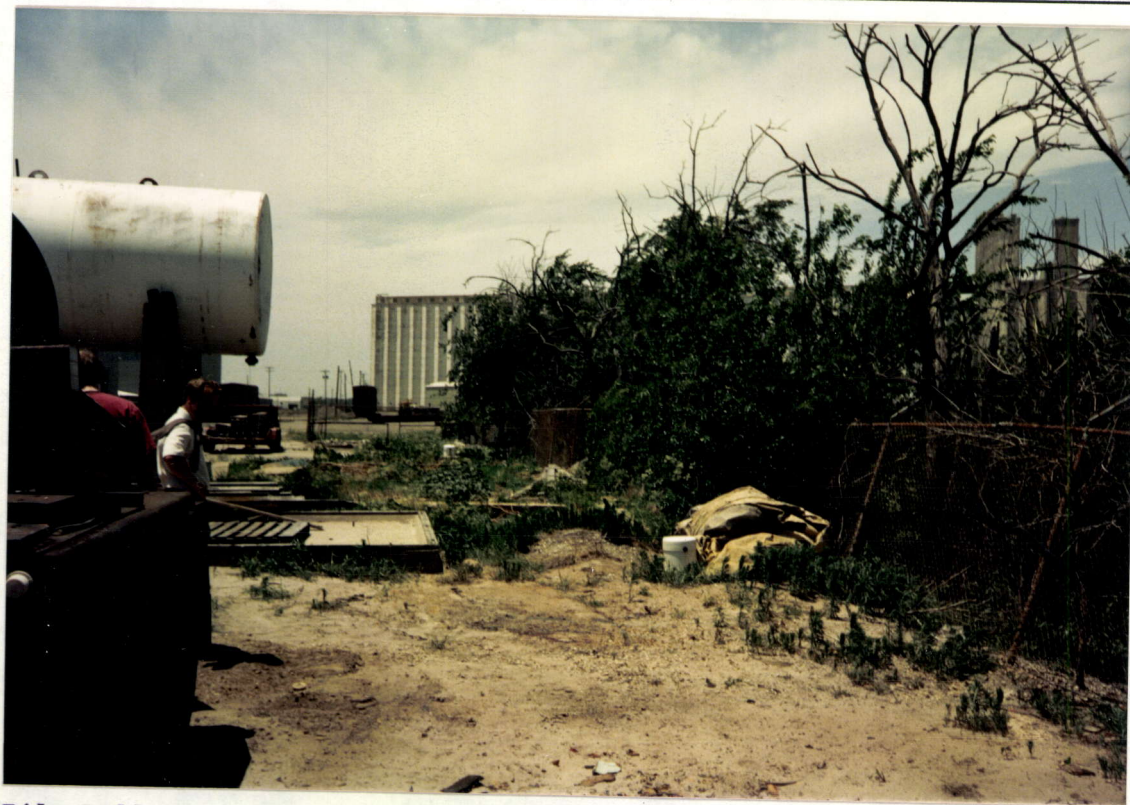
Film Roll No.: 2 Date: 6/19/90 Time: 1415
 Exposure No.: 15 Photographer: JPN
 VSI Observations: Fence line between SCSC and drainageway.
View - NW to N
